EB-133E
FILE COPY
FINAL PROGRESS REPORT
HOT AIR BALLOONS '59

Office of Naval Research
Department of the Navy
Washington 25, D. C.

MECHANICAL DIVISION OF
GENERAL MILLS, INC.
1620 Central Avenue
Minneapolis 13, Minnesota

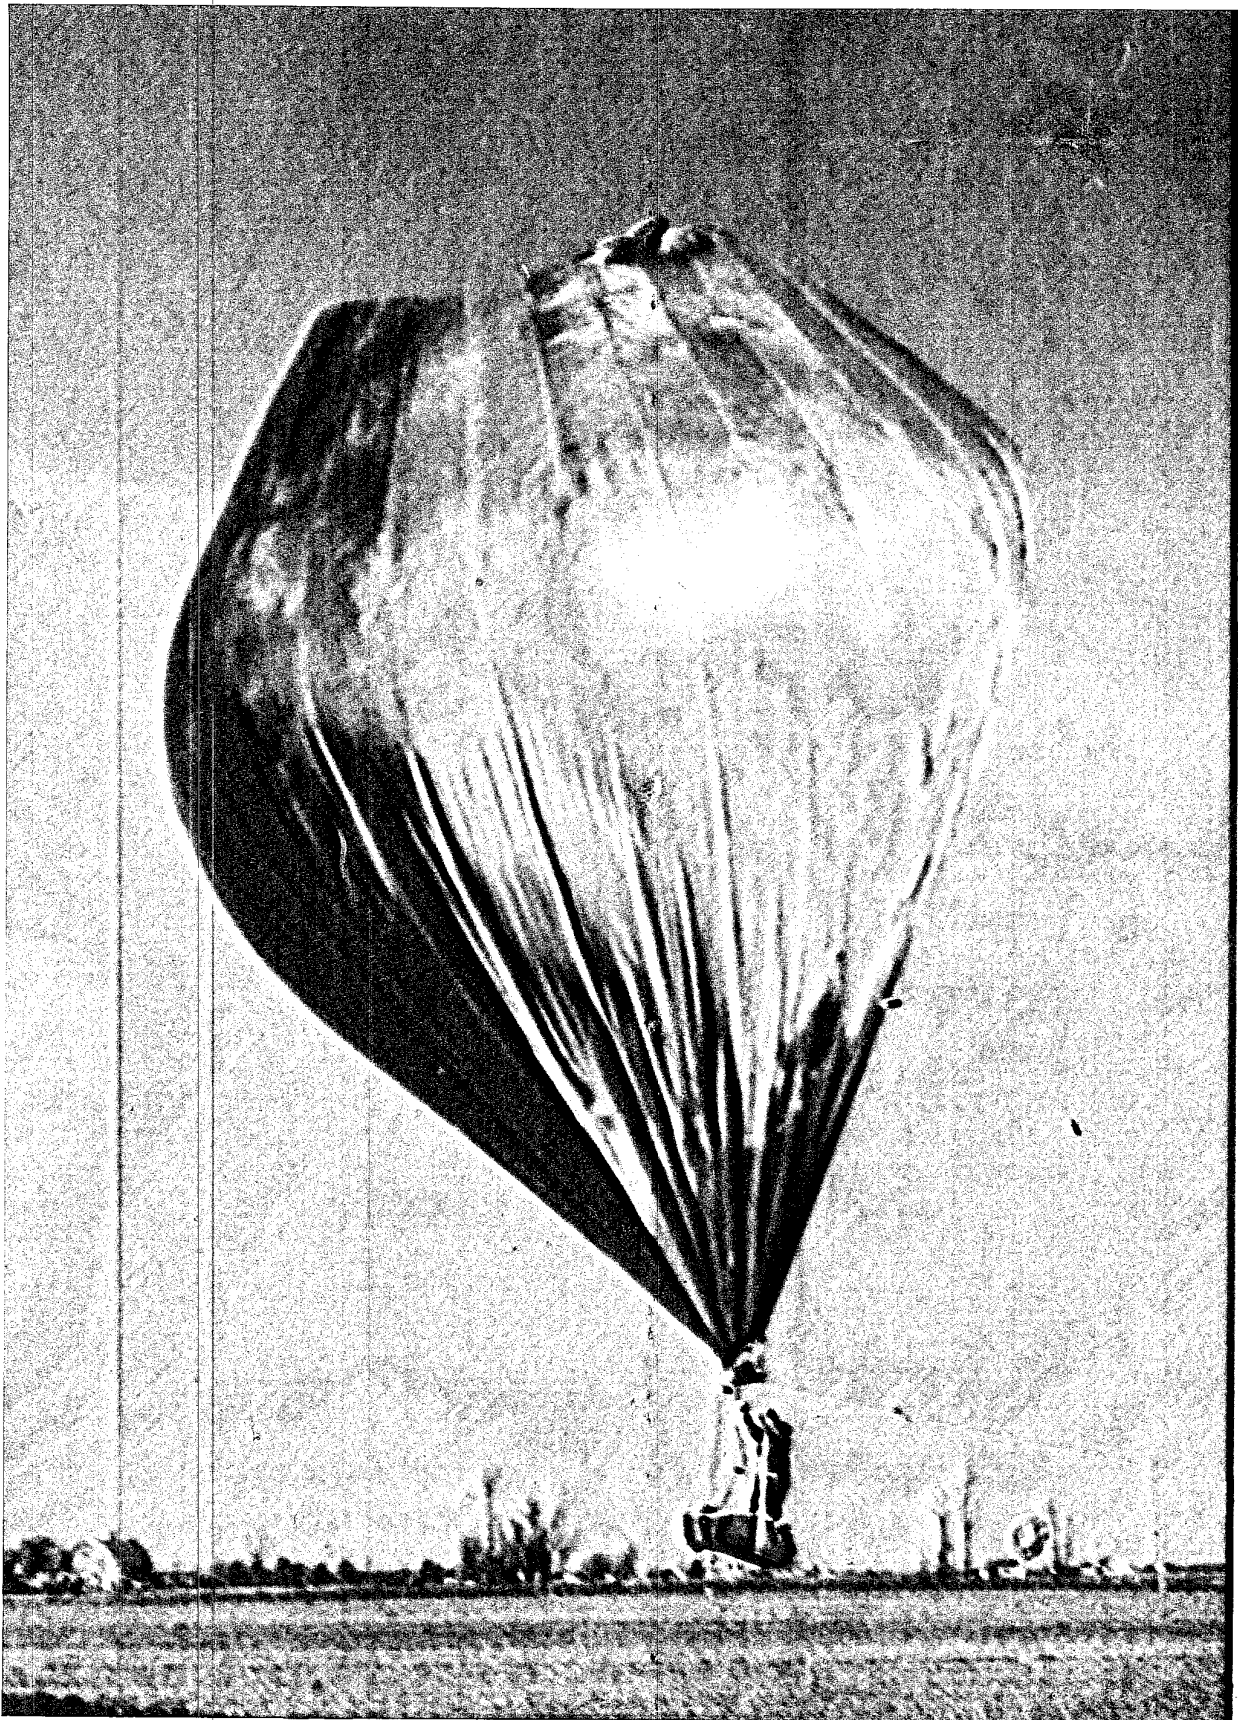
Balloon beginning deflation after
release of end fitting

Photograph No. 1 was taken during this flight and shows the balloon

at the beginning of the deflation period. This picture was taken immediately after the top of the balloon was released as the balloon descended.
